Acuant Scanner Failed to create LnlSourceIDScan.IDScanPersonDataSource Error: 0x80040154

Last Modified on 10/06/2022 4:16 am EDT

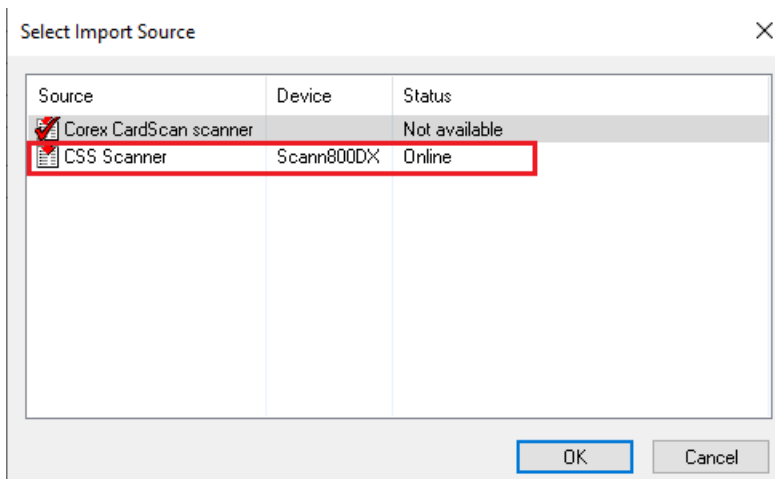
13. When clicked on the "Import" button there is an error message box pop displayed: "Internal logic error: Failed to create LnlSourceIDScan.IDScanPersonDataSource Error code 0x80040154" and logged to LenelError.log. Most likely the scanner device is not detected, configured properly, or the SDK driver's installation has a problem. Verify Scanner device was added correctly in the SA Administration->Workstation->Encoders/Scanner Tab. Check scanner status in the Device Manger. Disconnect, next reconnect the scanner device. If still problem observed delete the scanner in the SA Administration->Workstation Tab. Restart the entire workstation, next launch the System Administration and add the scanner again. Ensure during this process any other external software is not connected or using the scanner. Repeat adding New Cardholder by Importing personal data from scanned ID process again.

12. Click on the Tab Administration, then from pop up menu select Cardholder option. In the Cardholder form Select “Add”, next “Import” button. The Select Import Source dialog should pop up.

Select the CCS Scanner, ensure the check in mark is on it and its status is online.
